Patient Injury Potential from Mechanical CPR Devices During Collision: Comparison of Load-Distributing Band Versus Piston-Driven Systems

TECHNICAL REPORT

NO. 3

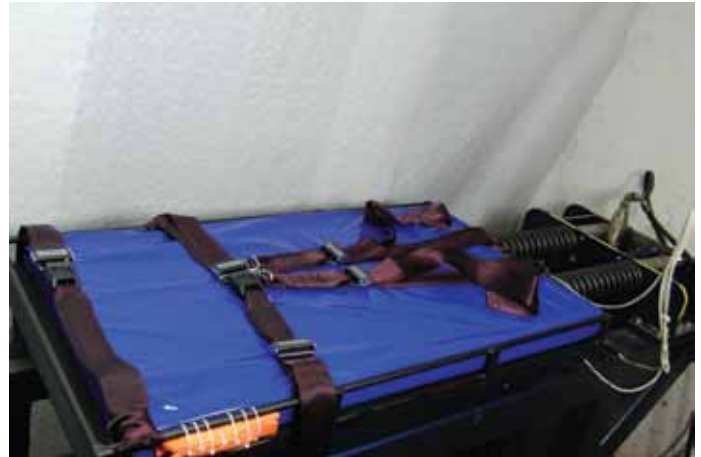
Figure 1: Test sled with stretcher and shoulder harness.

Method: Two different mechanical CPR systems were evaluated during simulated, rapid deceleration. Both piston-driven (Lucas™ 2) and load-distributing band (AutoPulse®) systems were tested. The test was conducted on a spring-driven crash sled to which an ambulance stretcher (including mattress and rails) was mounted (Figure 1). The test fixture complies with the requirements of DIN EN 1789 in that it could produce a calibrated g-force in 5 directions for a period of no less than 50 milliseconds.

The CPR systems were applied to a full body mannequin (Muckle Mannequins Polyman) in accordance with the manufacturer's recommendations.^{1,2} The mannequin was strapped onto the stretcher using a standard five-point harness (Ferno, Inc.).

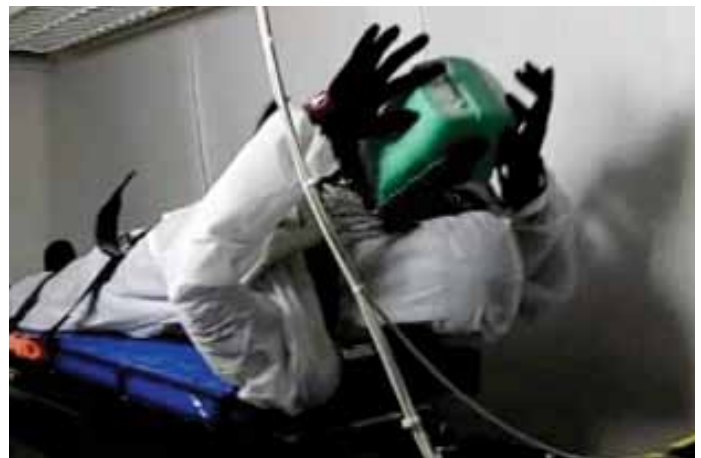
Figure 2: The top-heavy mass of the piston-driven system forcefully impacts the mannequin's head at 250 milliseconds.

- 1 It tilted to the point where the mass of the system (control unit, battery, and motor) forcefully impacted the mannequin's head (Figure 2).
- 2 The back of the mannequin was excessively deformed (Figure 3) in a manner suggesting some level of spinal injury.
- 3 The piston failed to stop despite it having moved to a non-therapeutic position (i.e. abdomen, lateral rib cage, etc.).

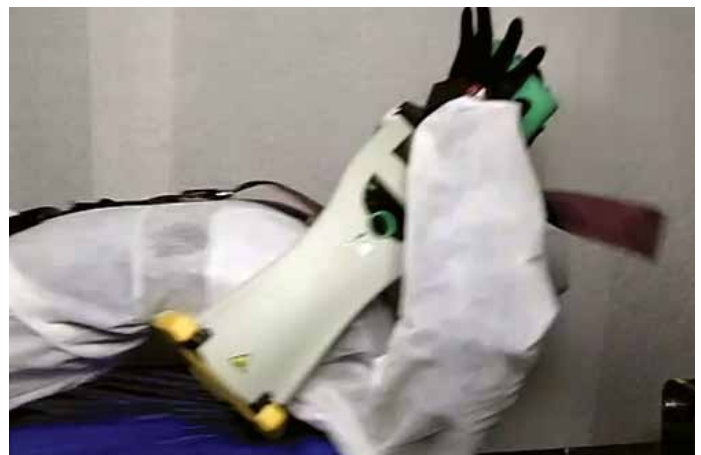
Figure 3: Lower part of the piston-driven system severely deforms the back of the mannequin at 250 milliseconds.

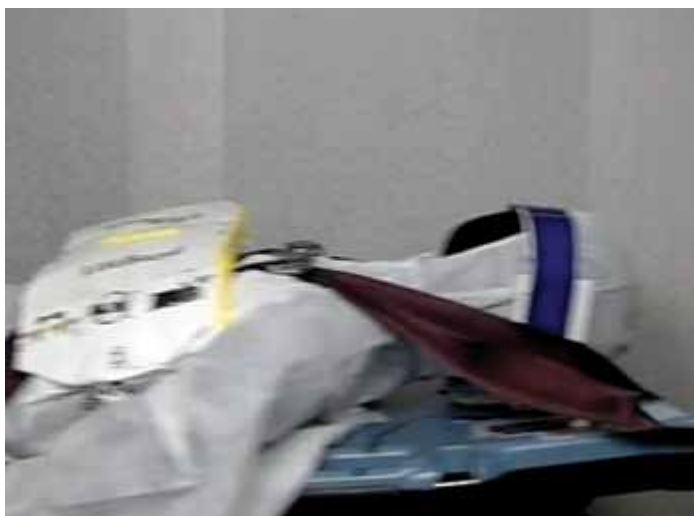
Figure 4: Minimal movement of the mannequin at 250 milliseconds with the load-distributing band system in use.

With the load-distributing band system, movement was limited adequately by the shoulder harness such that no abnormal forces were delivered to the mannequin (Image 4).
